The [REDACTED] has roof damage on multiple points. The following document will describe and visualize the damage.

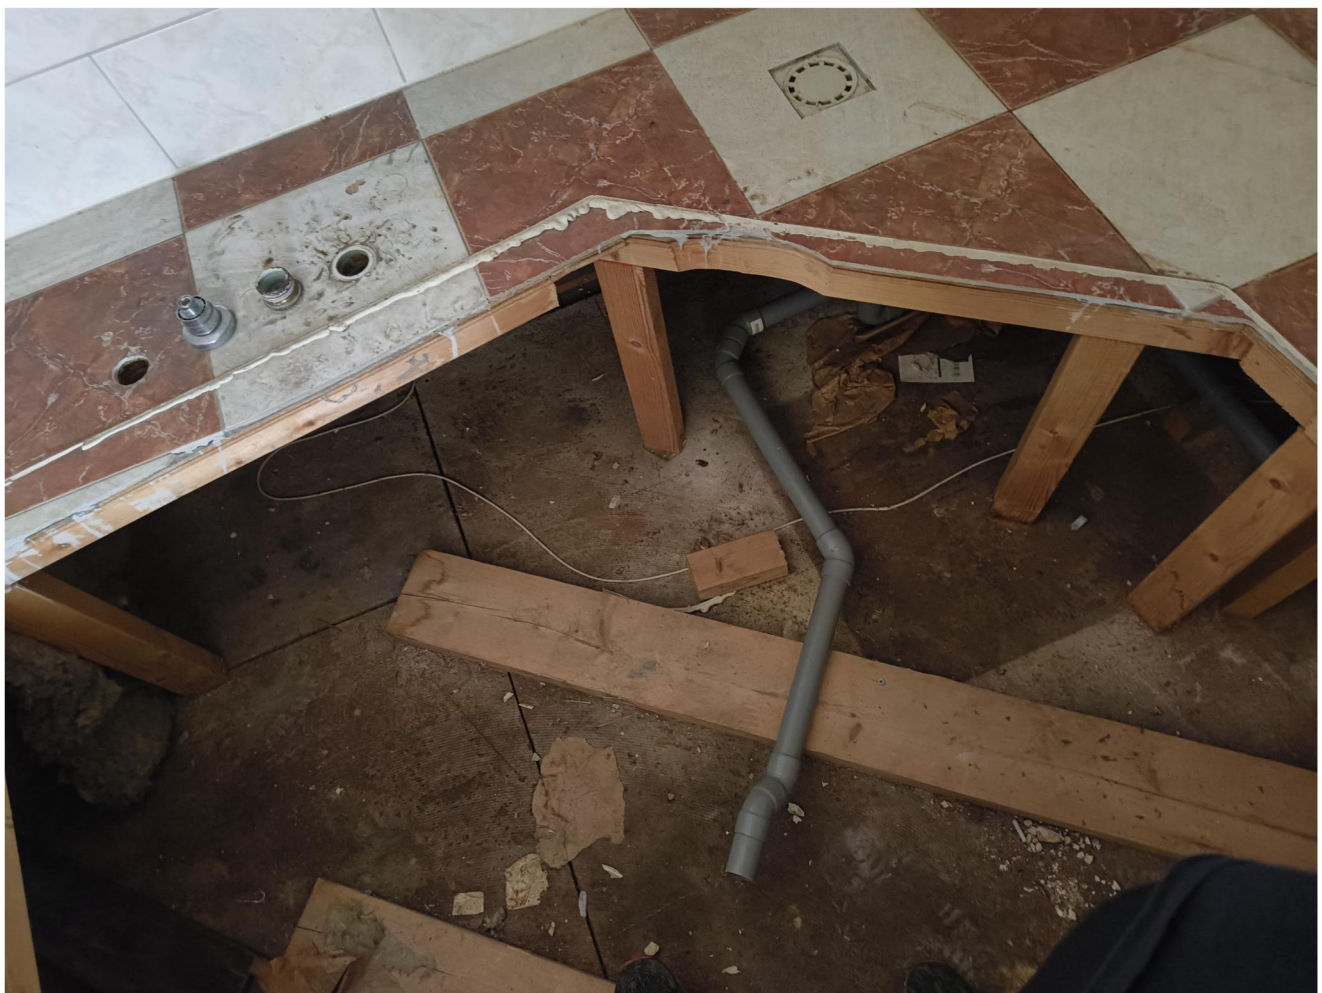
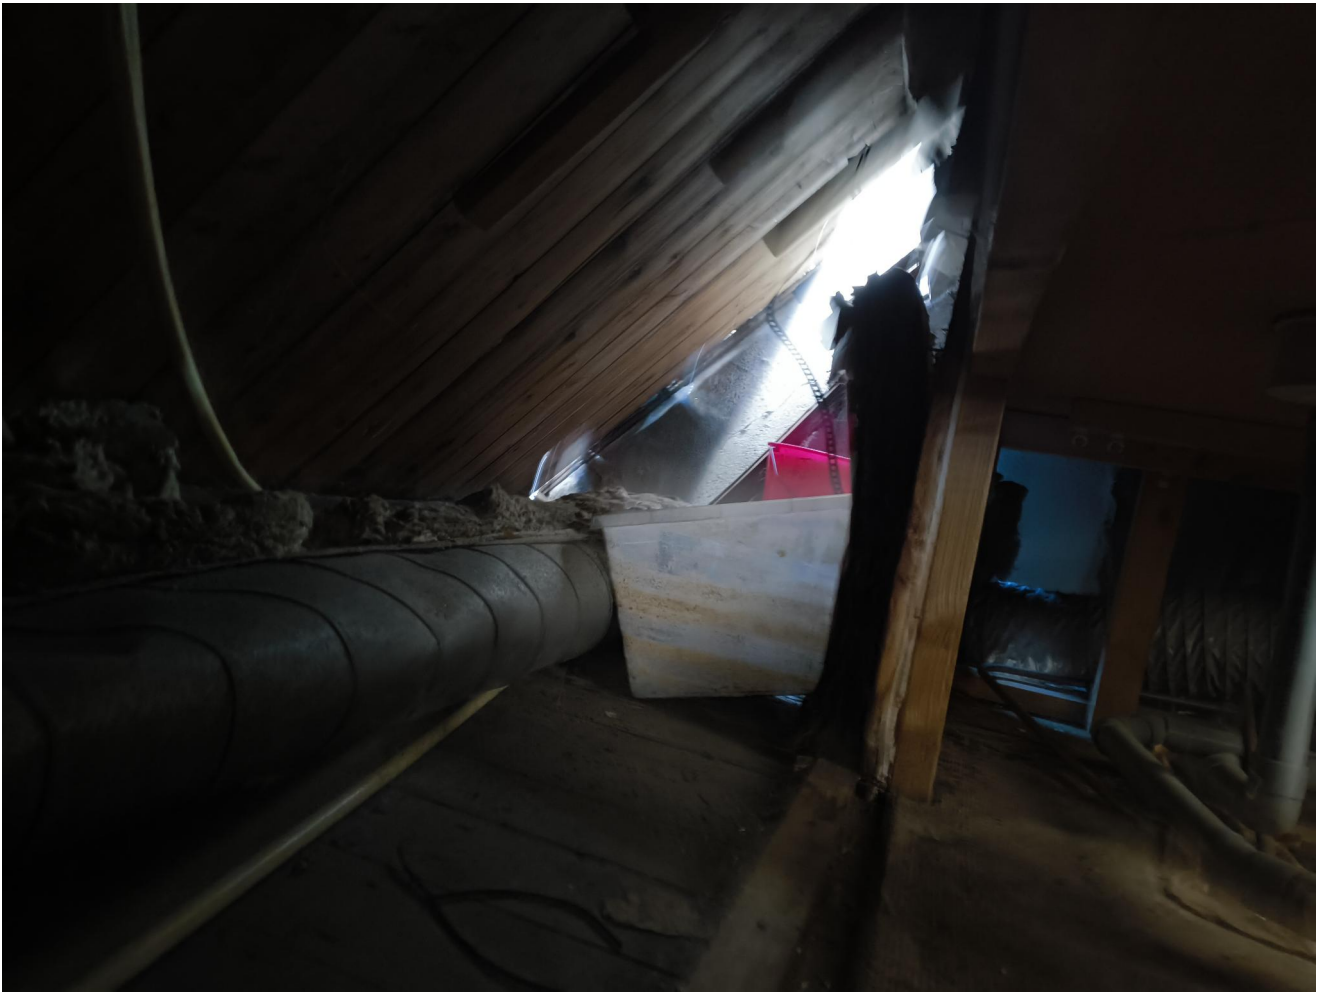
#### Floor 3 hole 1

We will start from the 3rd floor. When entering the floor and you look on the right there is a place where there was a bath tub once. Underneath there seems to be light coming from the far corner of the roof. When standing in front of the building it seems like the corner of the roof tiles is gone. This seems to be an easy enough fix.

On the floor beneath this spot there is the old kitchen. There seems to be no serious water damage there so my assessment is that this missing tile is not causing major damage but would be good to fix either way.

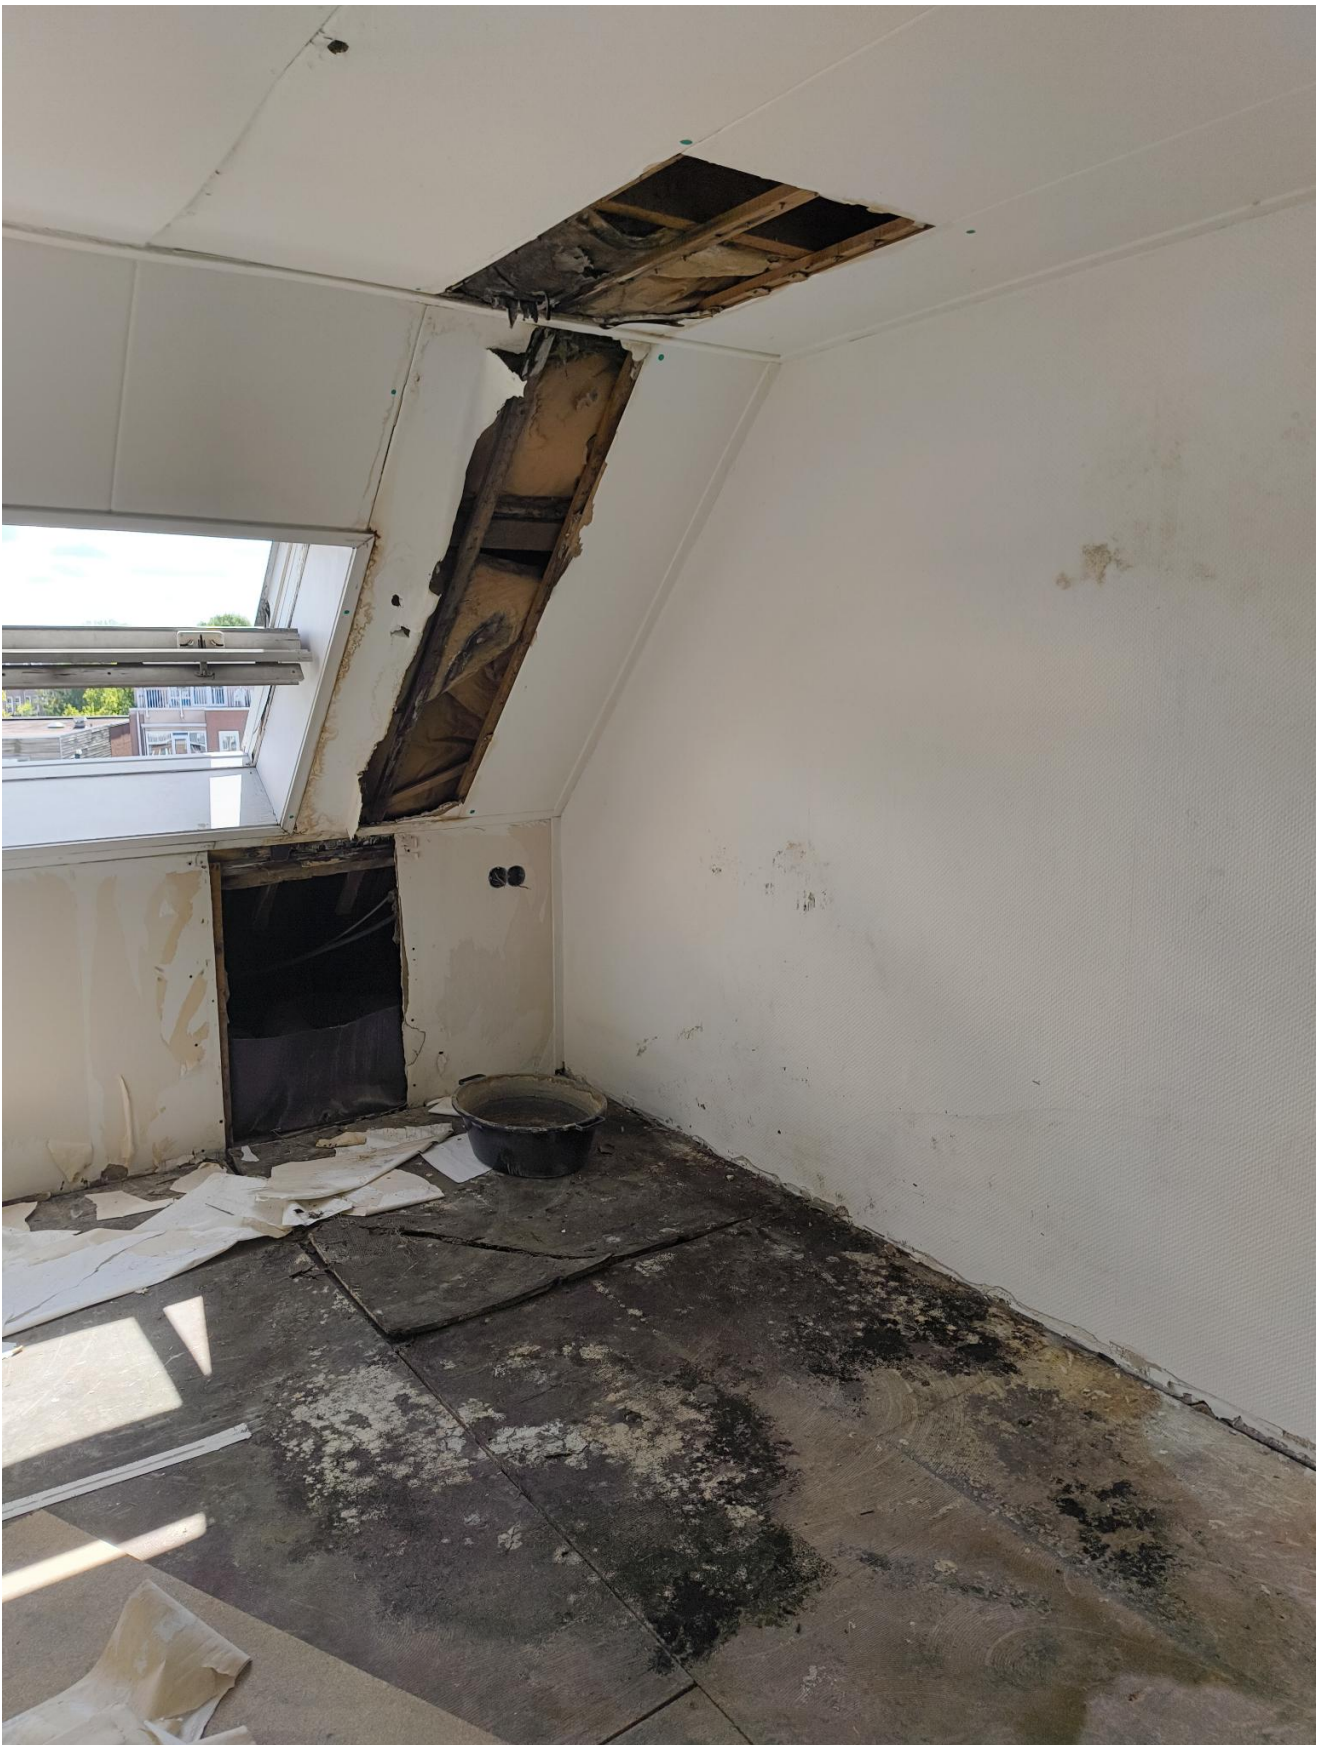
When moving across to the far end of the 3rd floor there is a room where the water damage is serious. The floor is seriously damaged and the damage has progressed to the floor below where there is clear signs of water damage on the walls. The hole in the roof seems to mostly due to 2 things.

- the ventilation that was installed here but is not functional anymore both on this floor and has connections on the attic
- The damage that followed from this ventilation on the structure and the collapsed tiles that can be seen from the outside.

Ceiling wall and floor damage

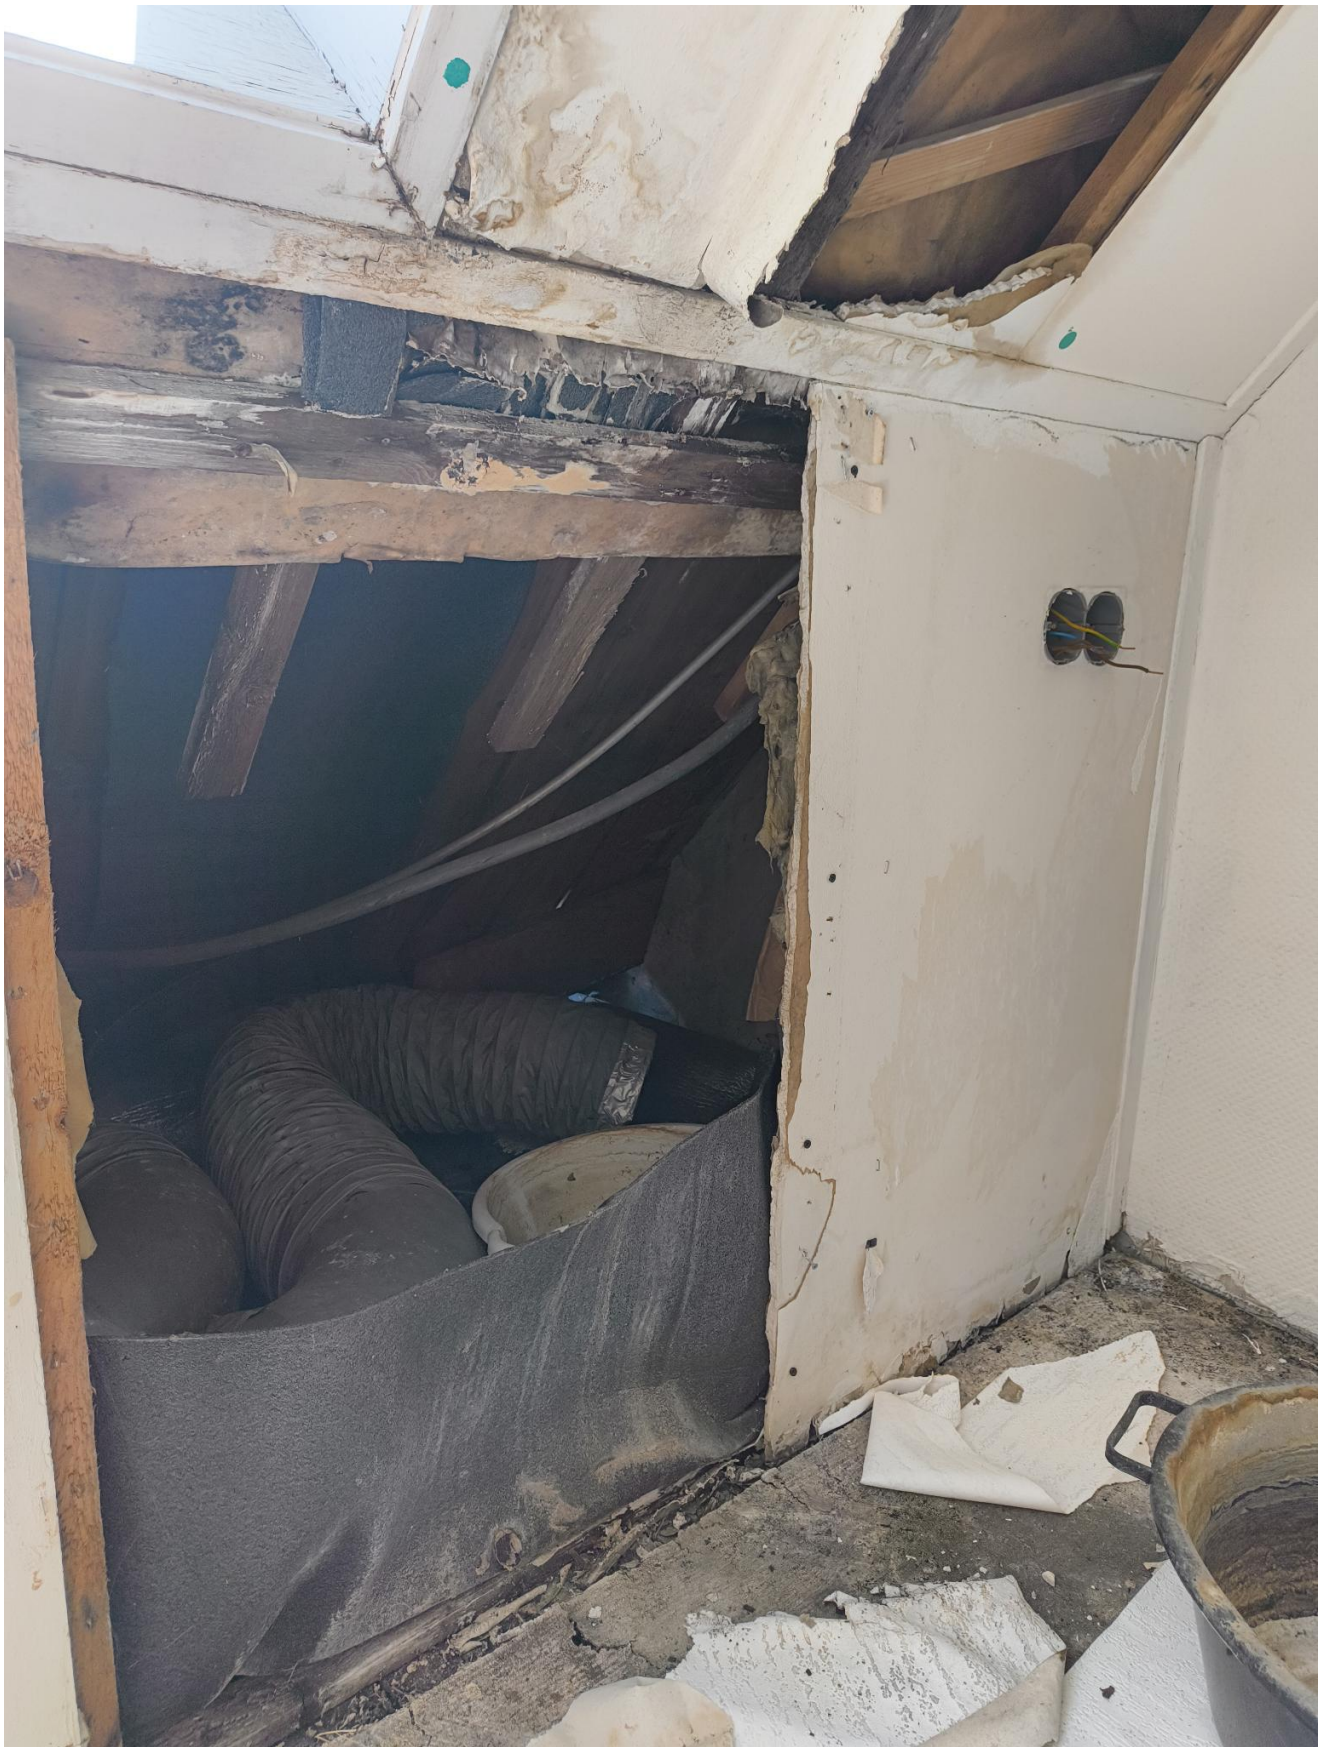
Light entering from roof

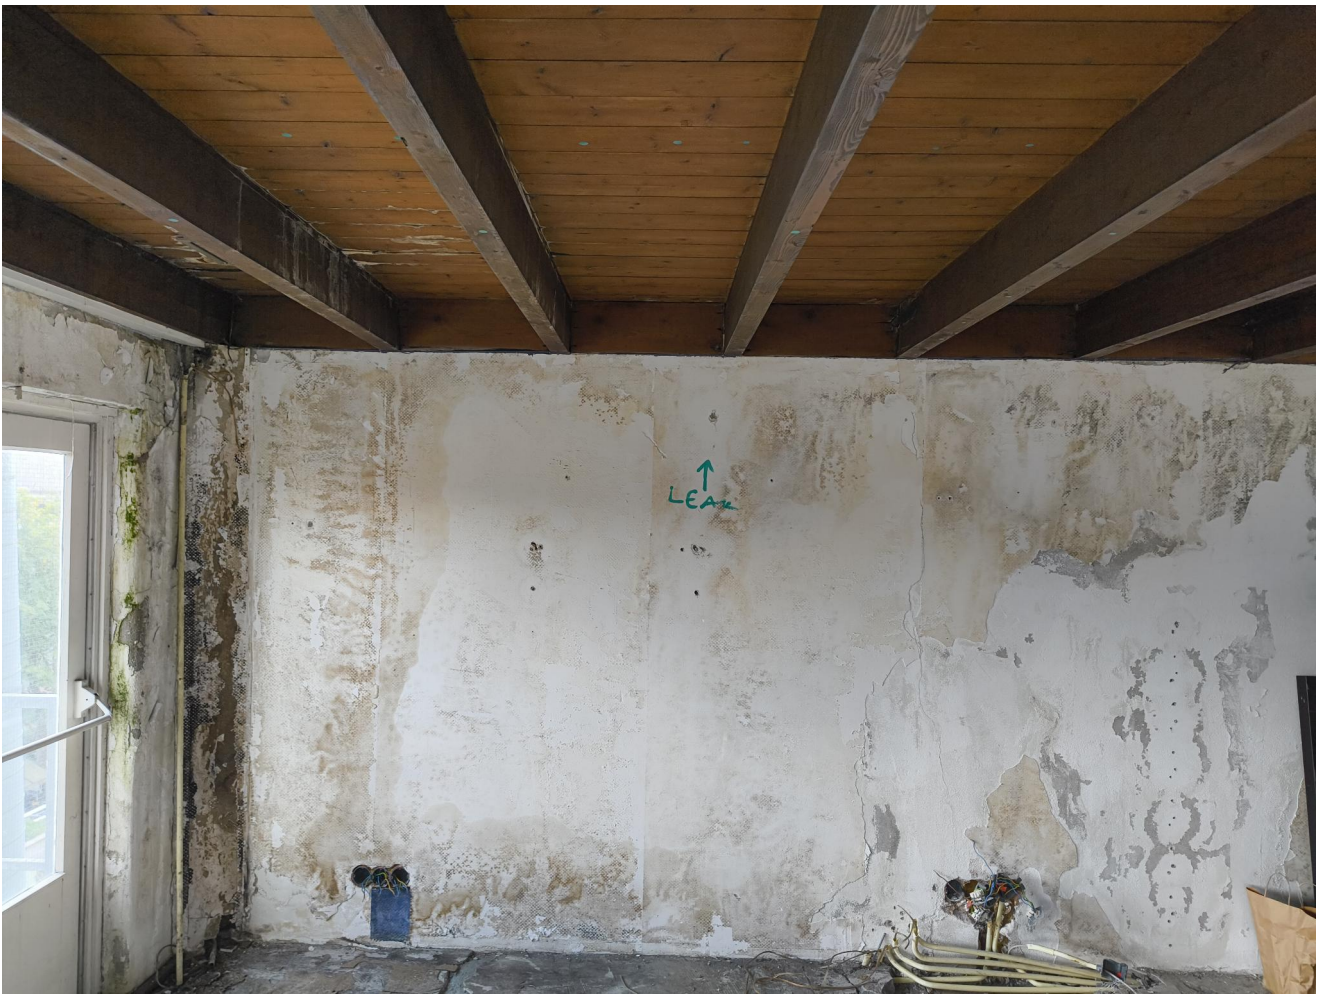
water damage floor 2

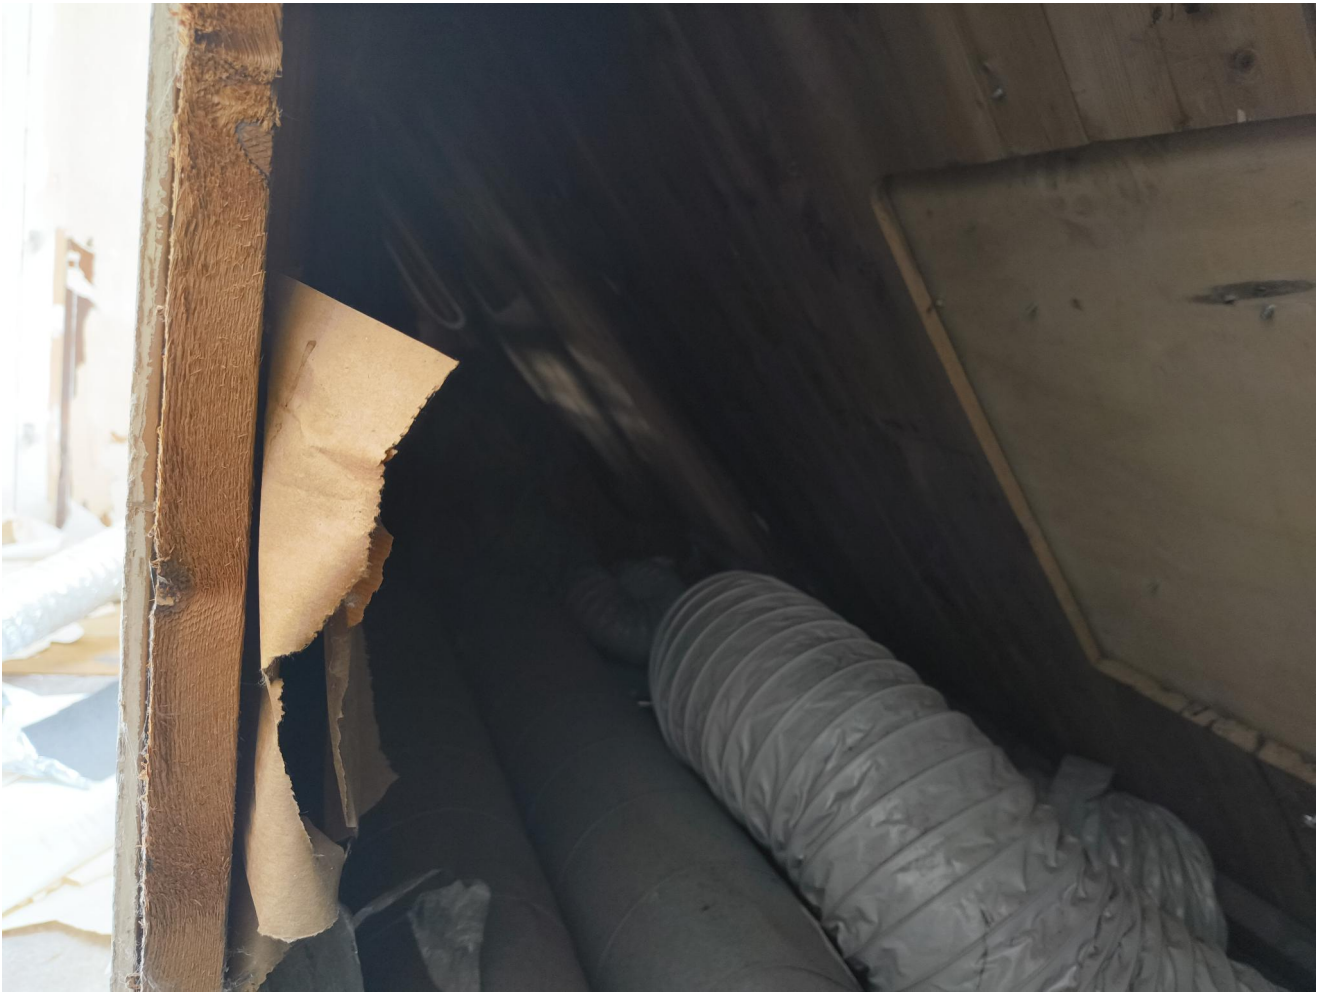
When looking through the open space of hole 2 you can see light enter on the left. There is clear damage on the door that exits to the fire escape. If one looks at the floor beneath it there is also clear damage to the window structure beneath it. I have not been able to pinpoint the source of the damage but there is some serious woodrot that has made the problem bigger than just a whole.

Light entering inside

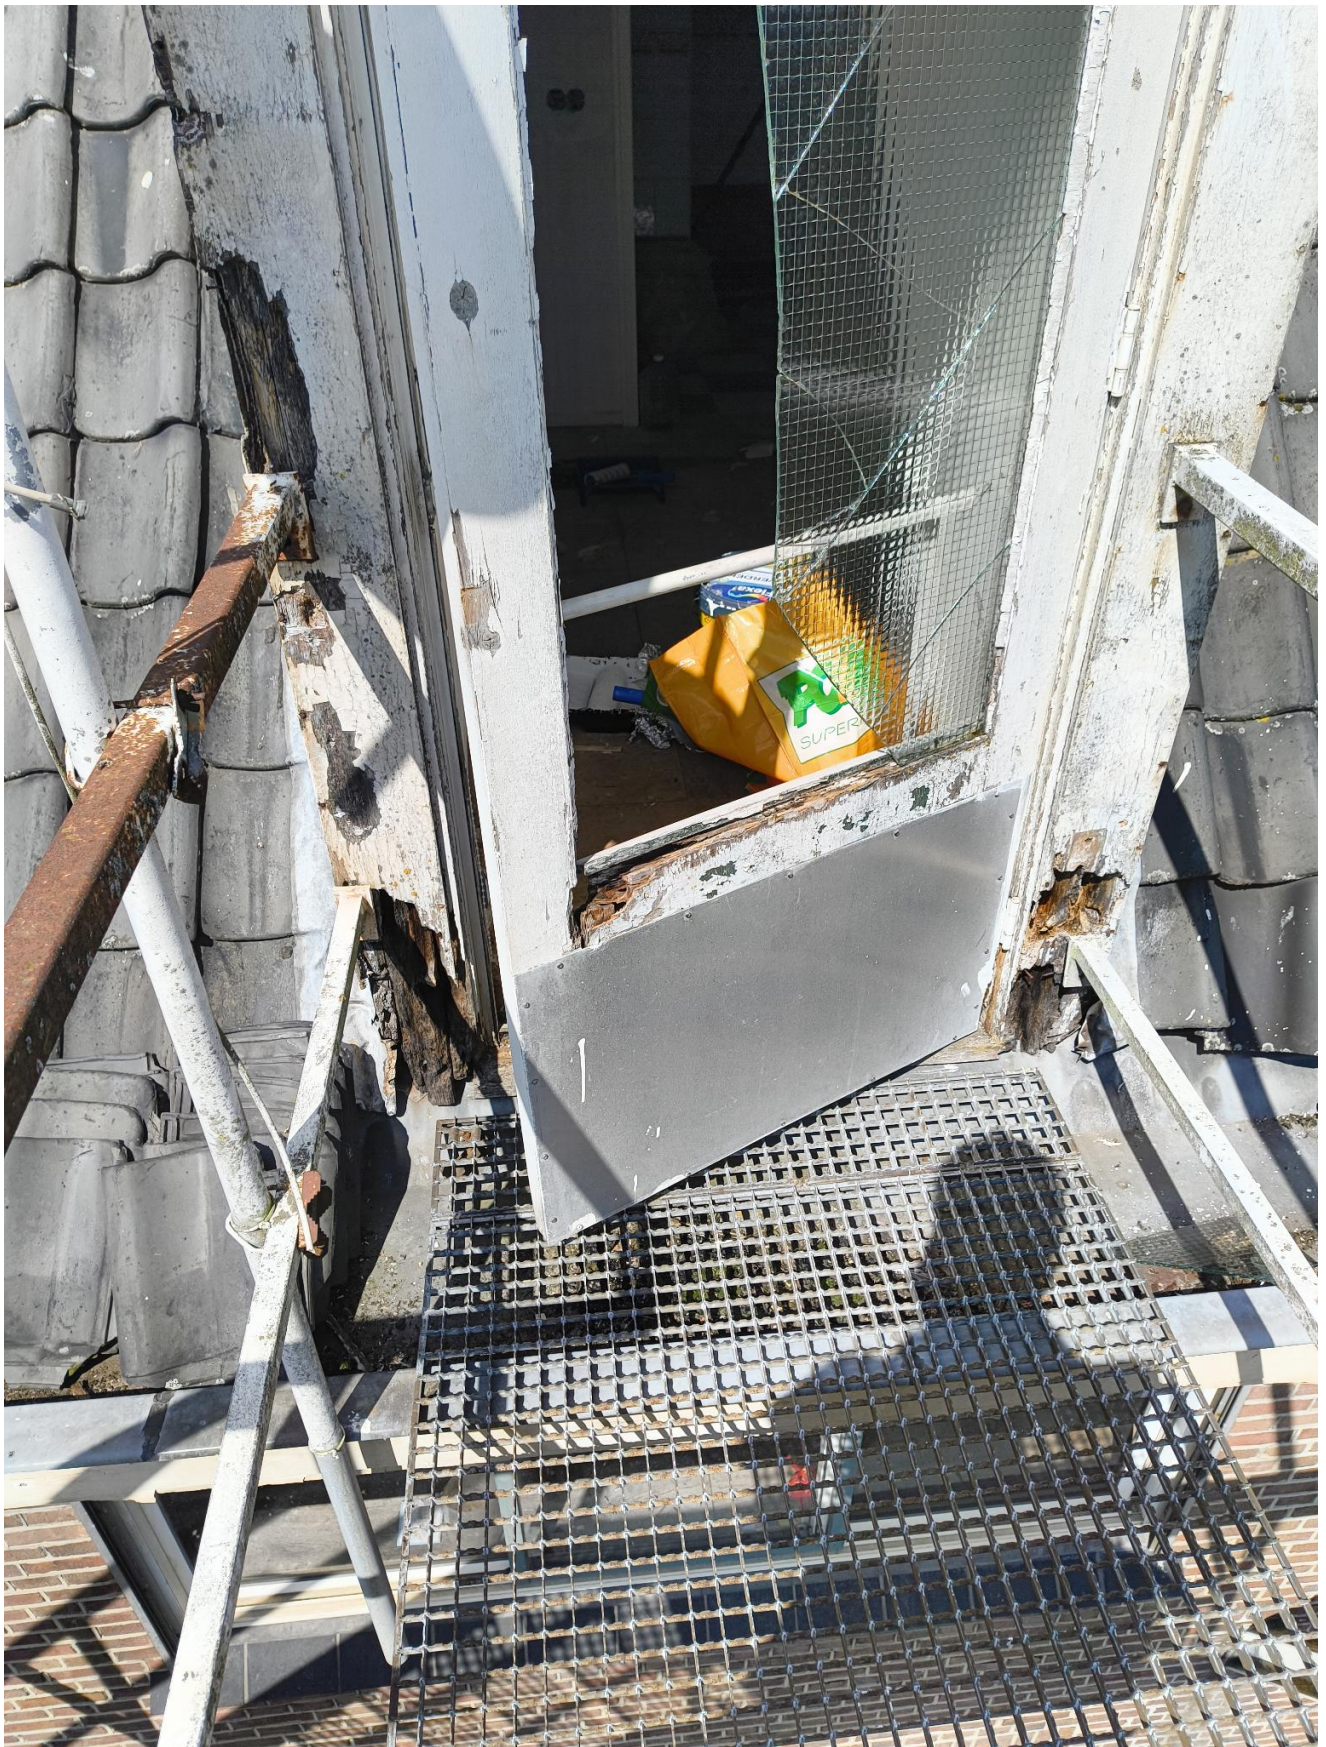
woodrot outside

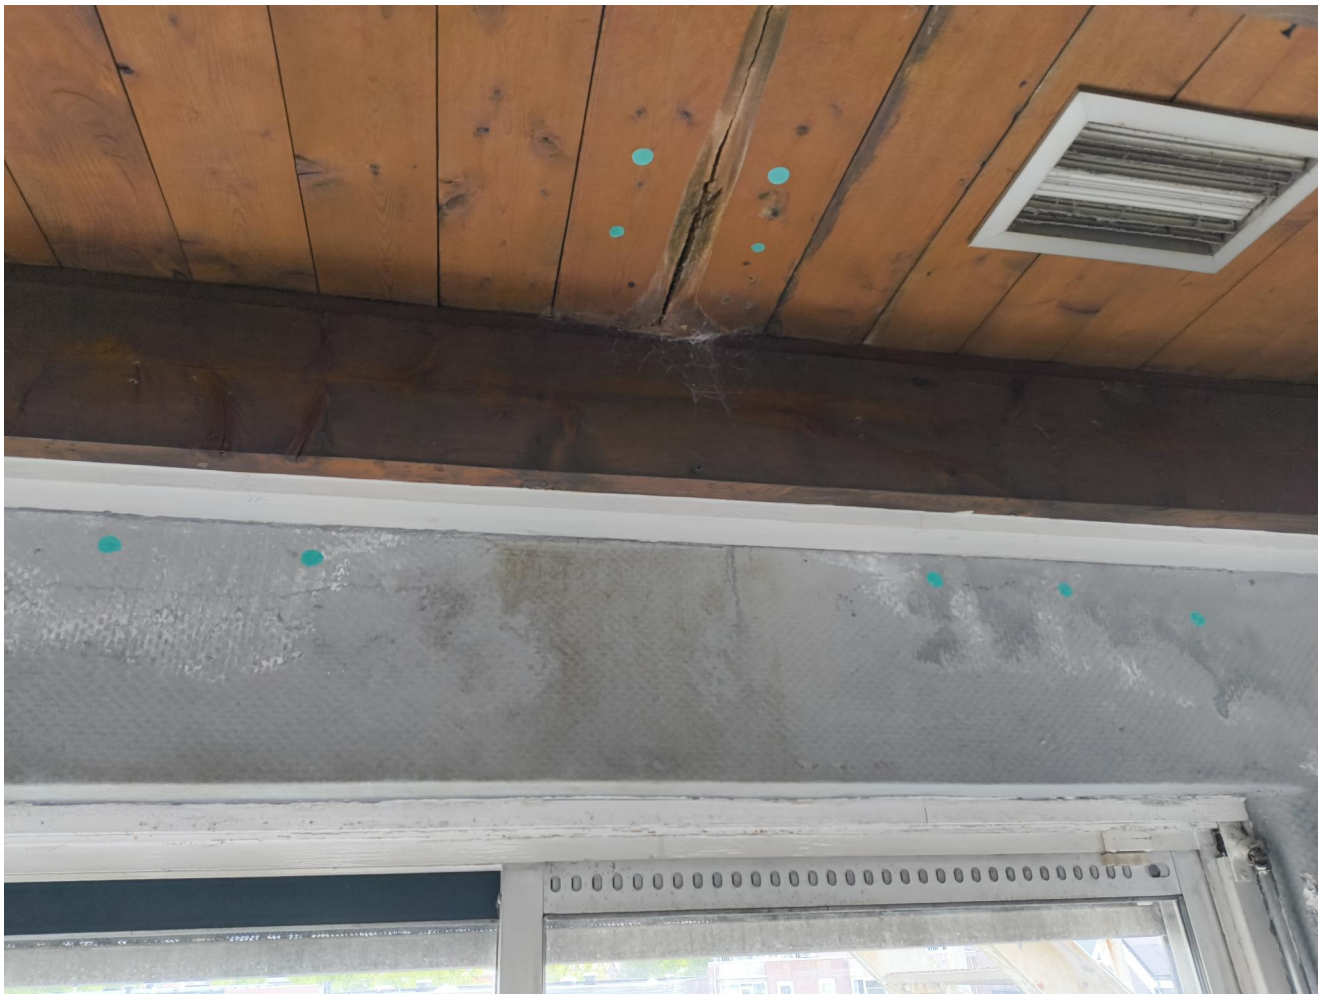
window damage floor 2

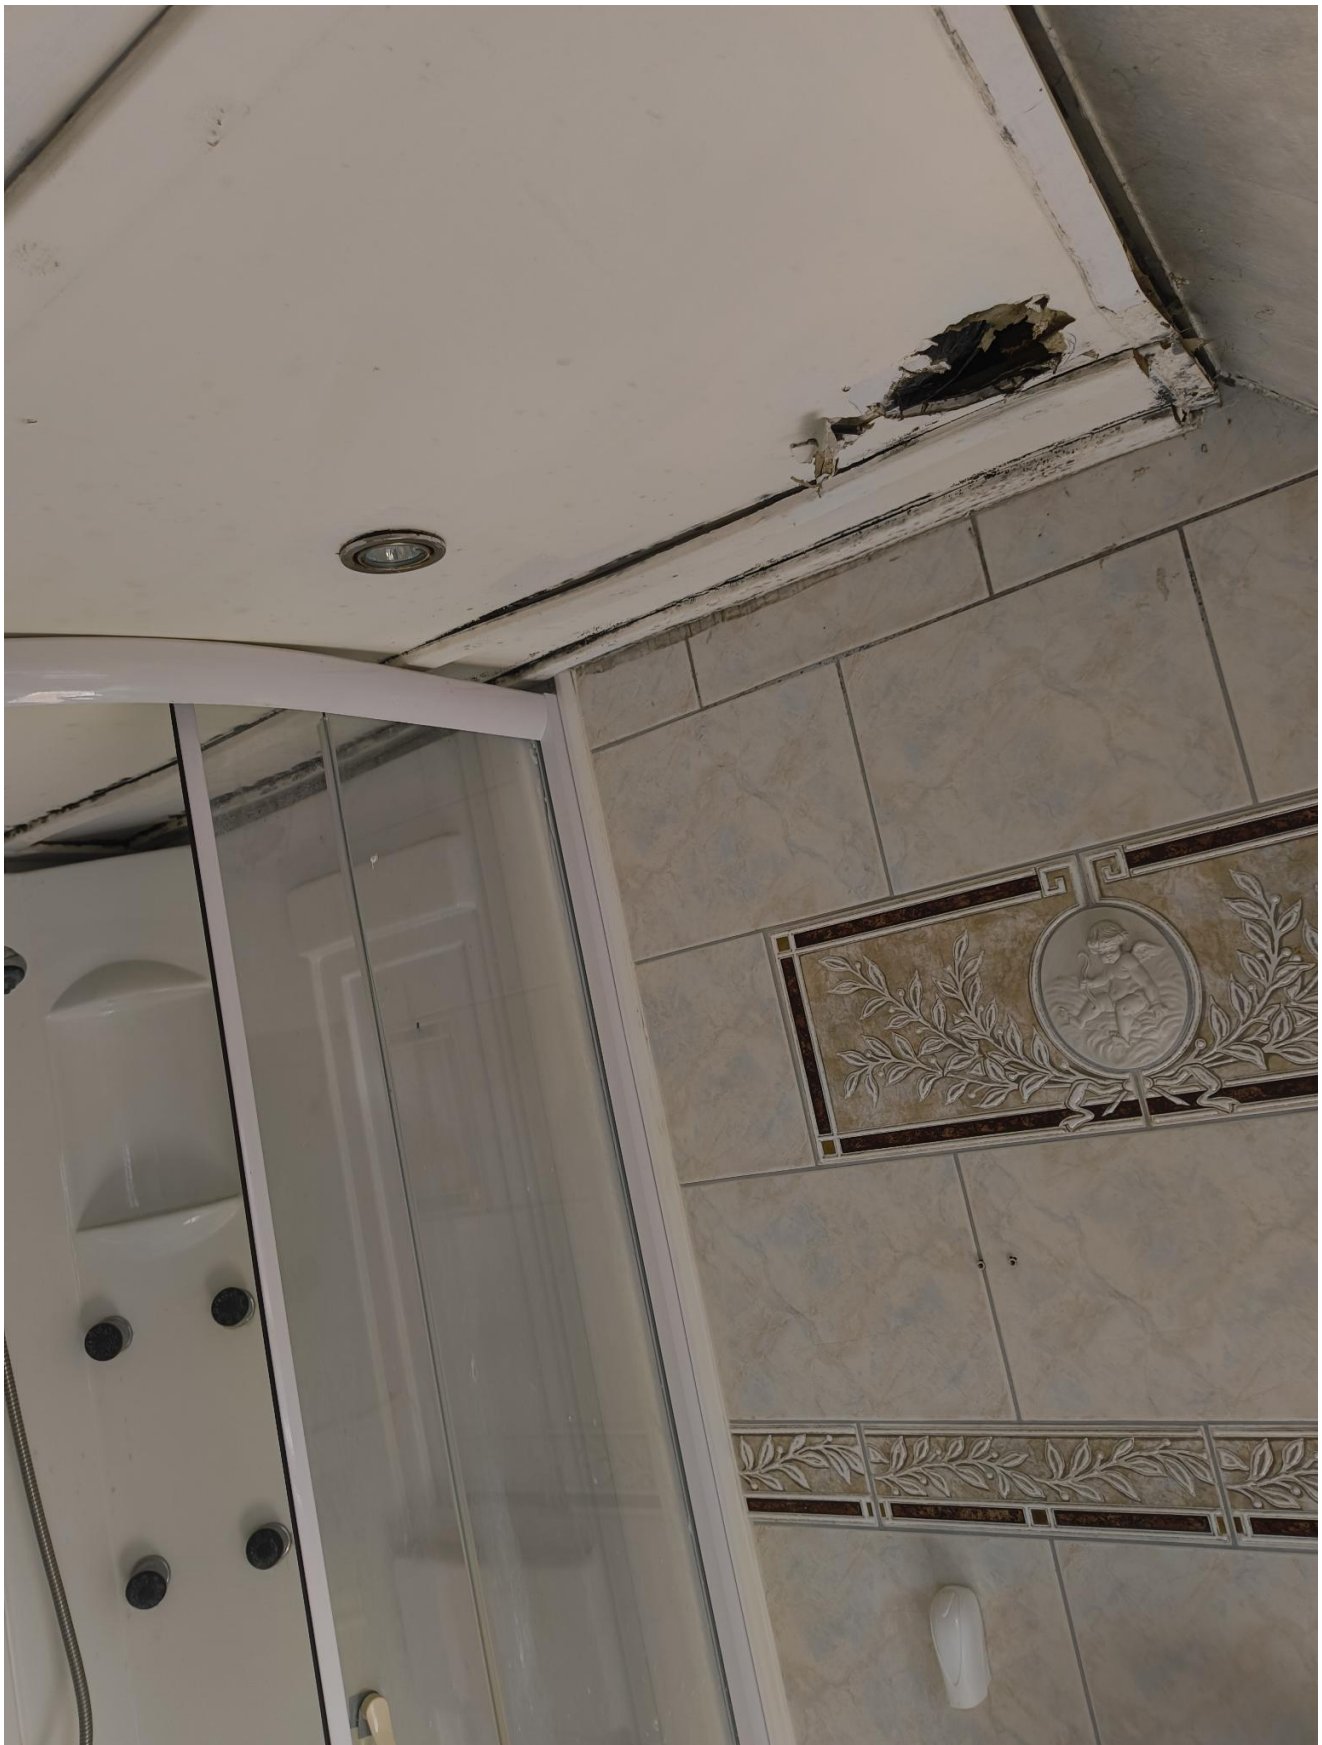
When entering the attic there are two ventilation pipes that exit through the slanted roof. These both let through light. There seems to be some water damage beneath there, especially in the shower where the ceiling is slumping and needs fixing to make the shower usable.

shower damage

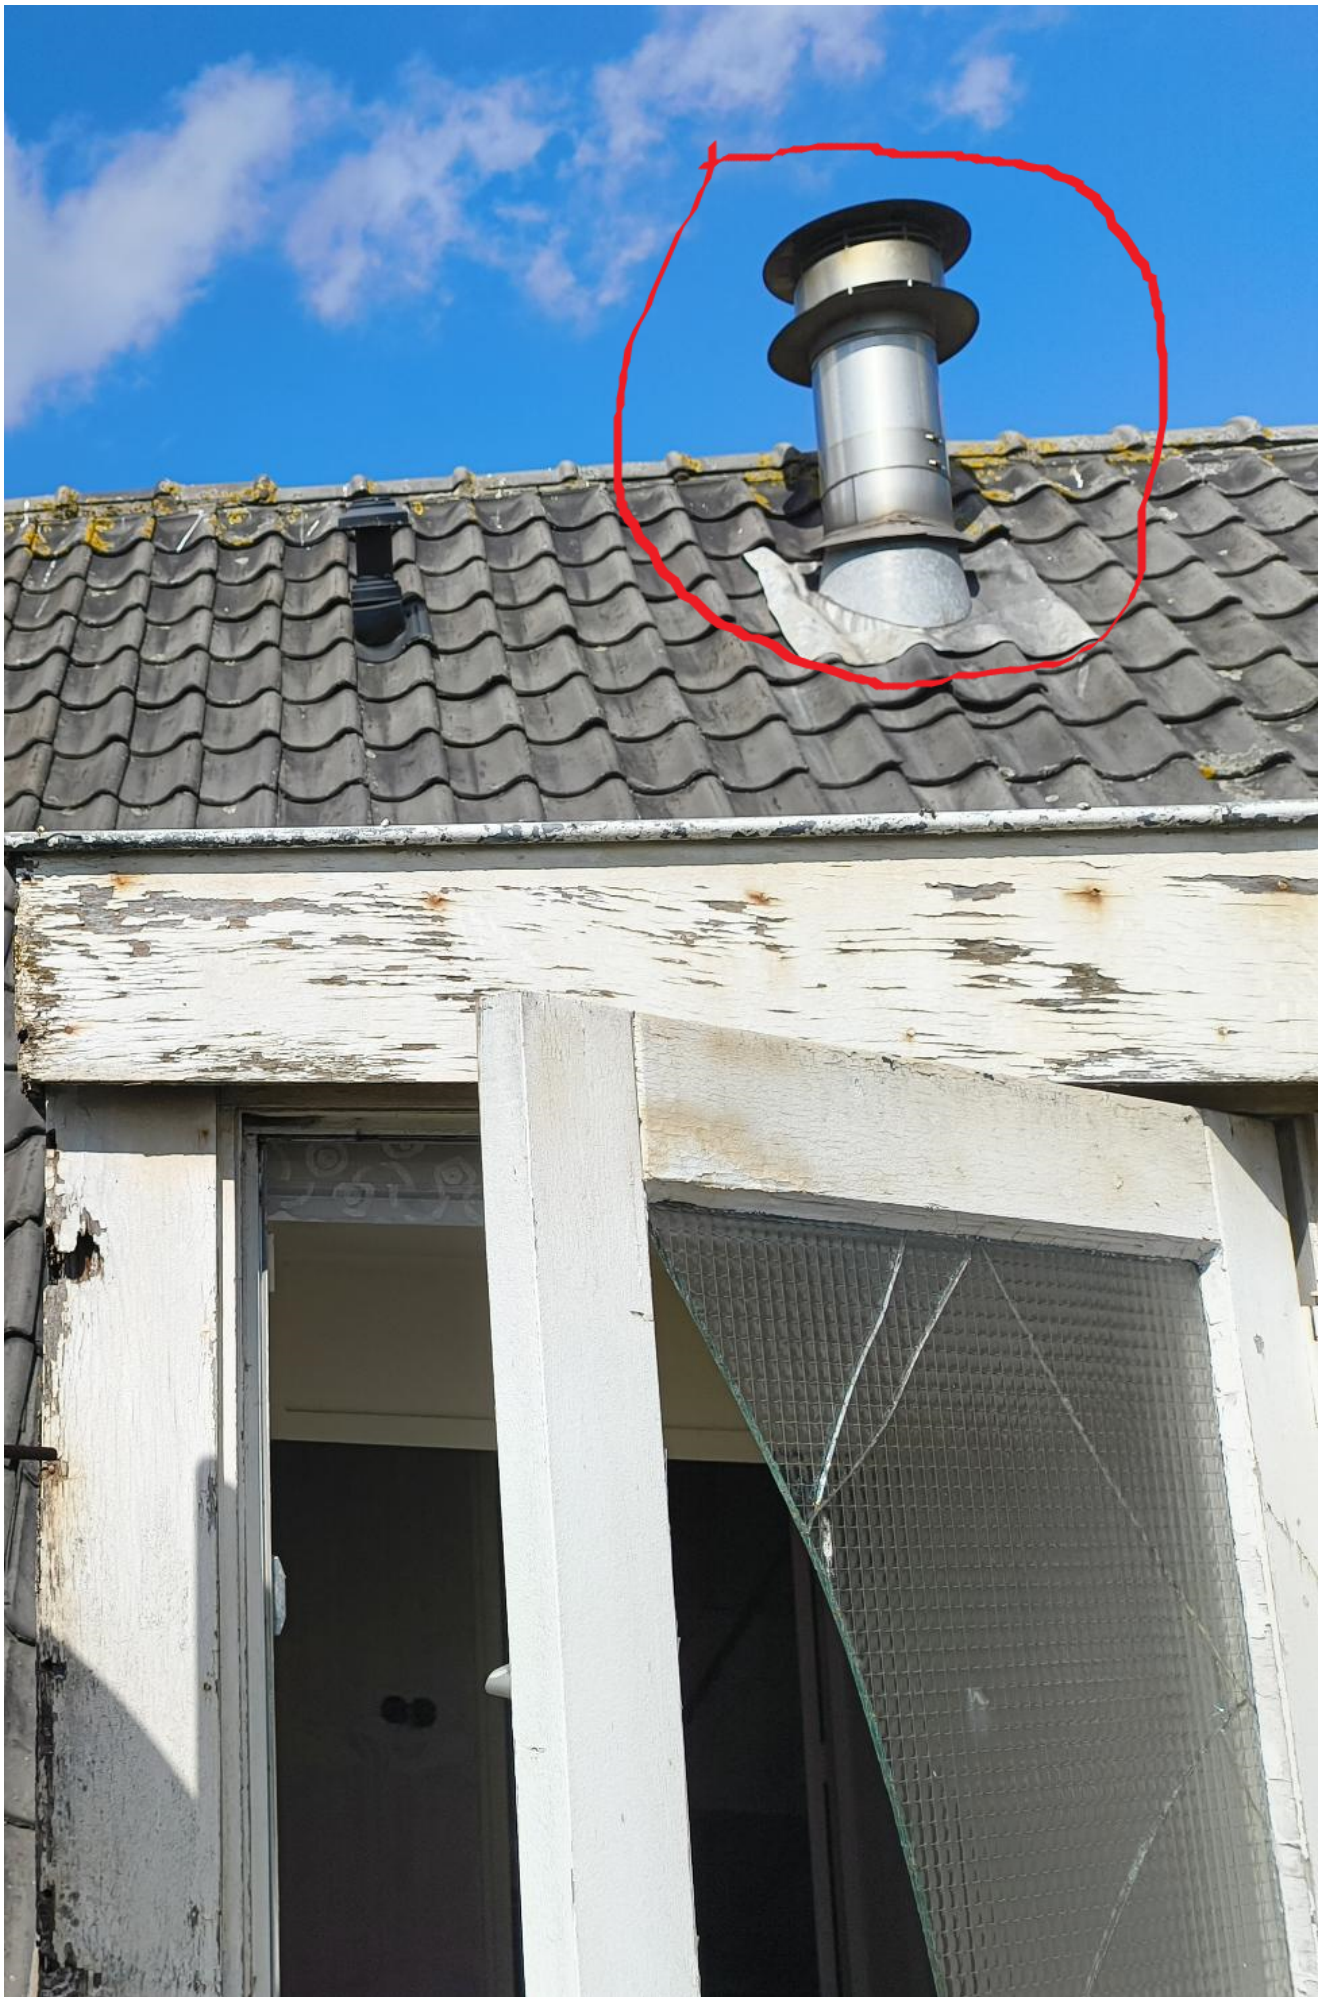
### Attic Hole 3

In the middle of the roof there is a big pipe going through the roof. This is presumably the ventilation of the fireplace at the second floor. There is clear signs of light coming through the sides of this pipe. There is a covering piece that is supposed to protect the building from leakage here. There seems to be no water damage beneath this point. However the amount of light coming through is cause for further inspection and possibly closing up the wholes.

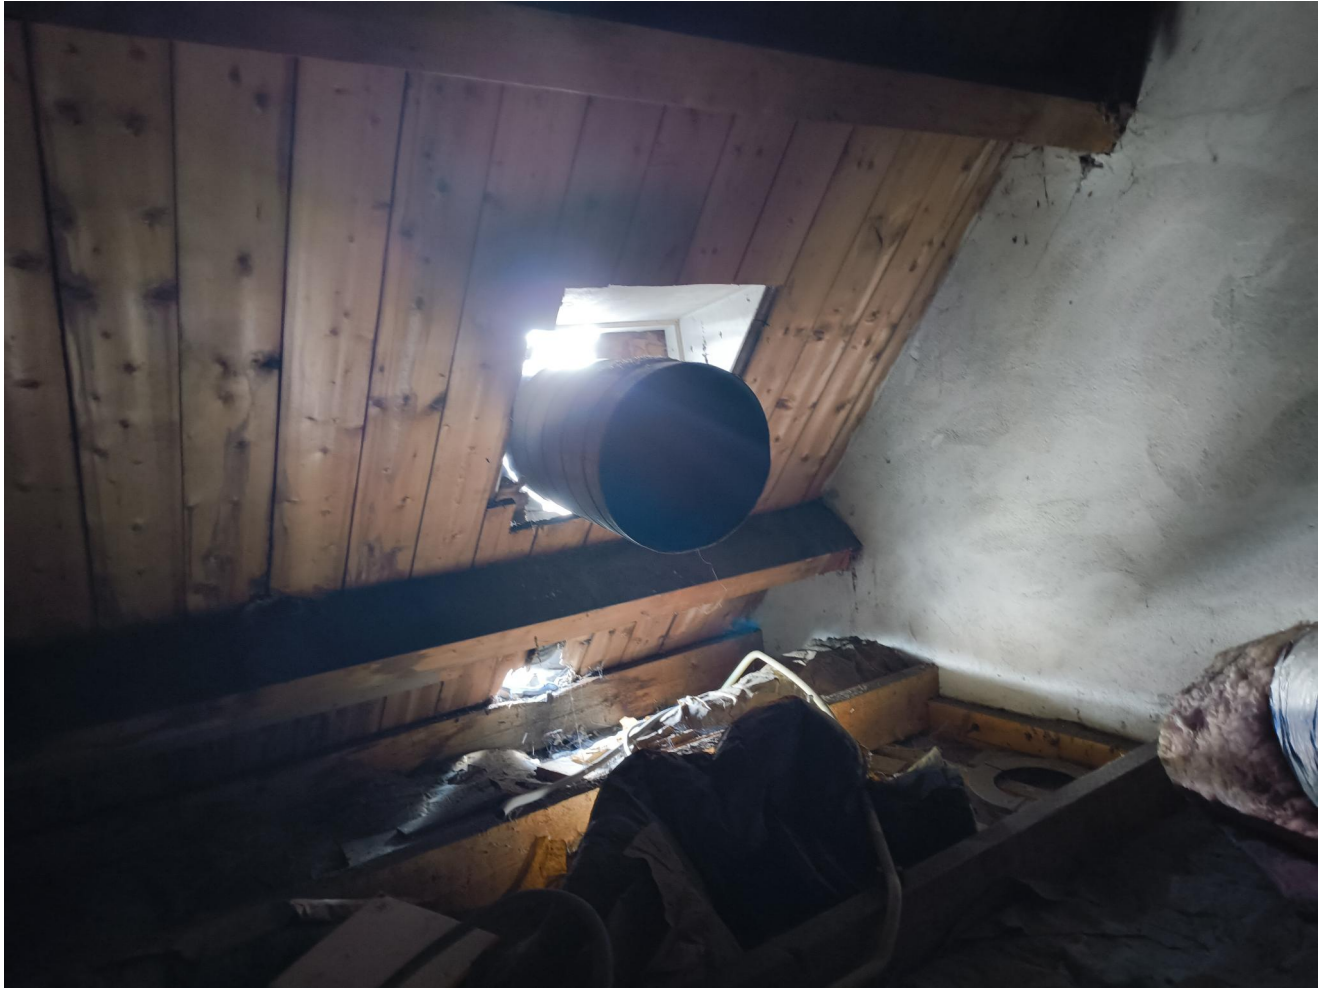
inside

This is the last hole at the far end of the attic. This is a ventilation pipe that is right above the Floor 3, hole 2 at the far end of the 3rd floor. This is part of the same problem. From the outside there is clear damage of slumping tiles that causes this to be one continuous problem causing the third floor and second floor to be damaged.

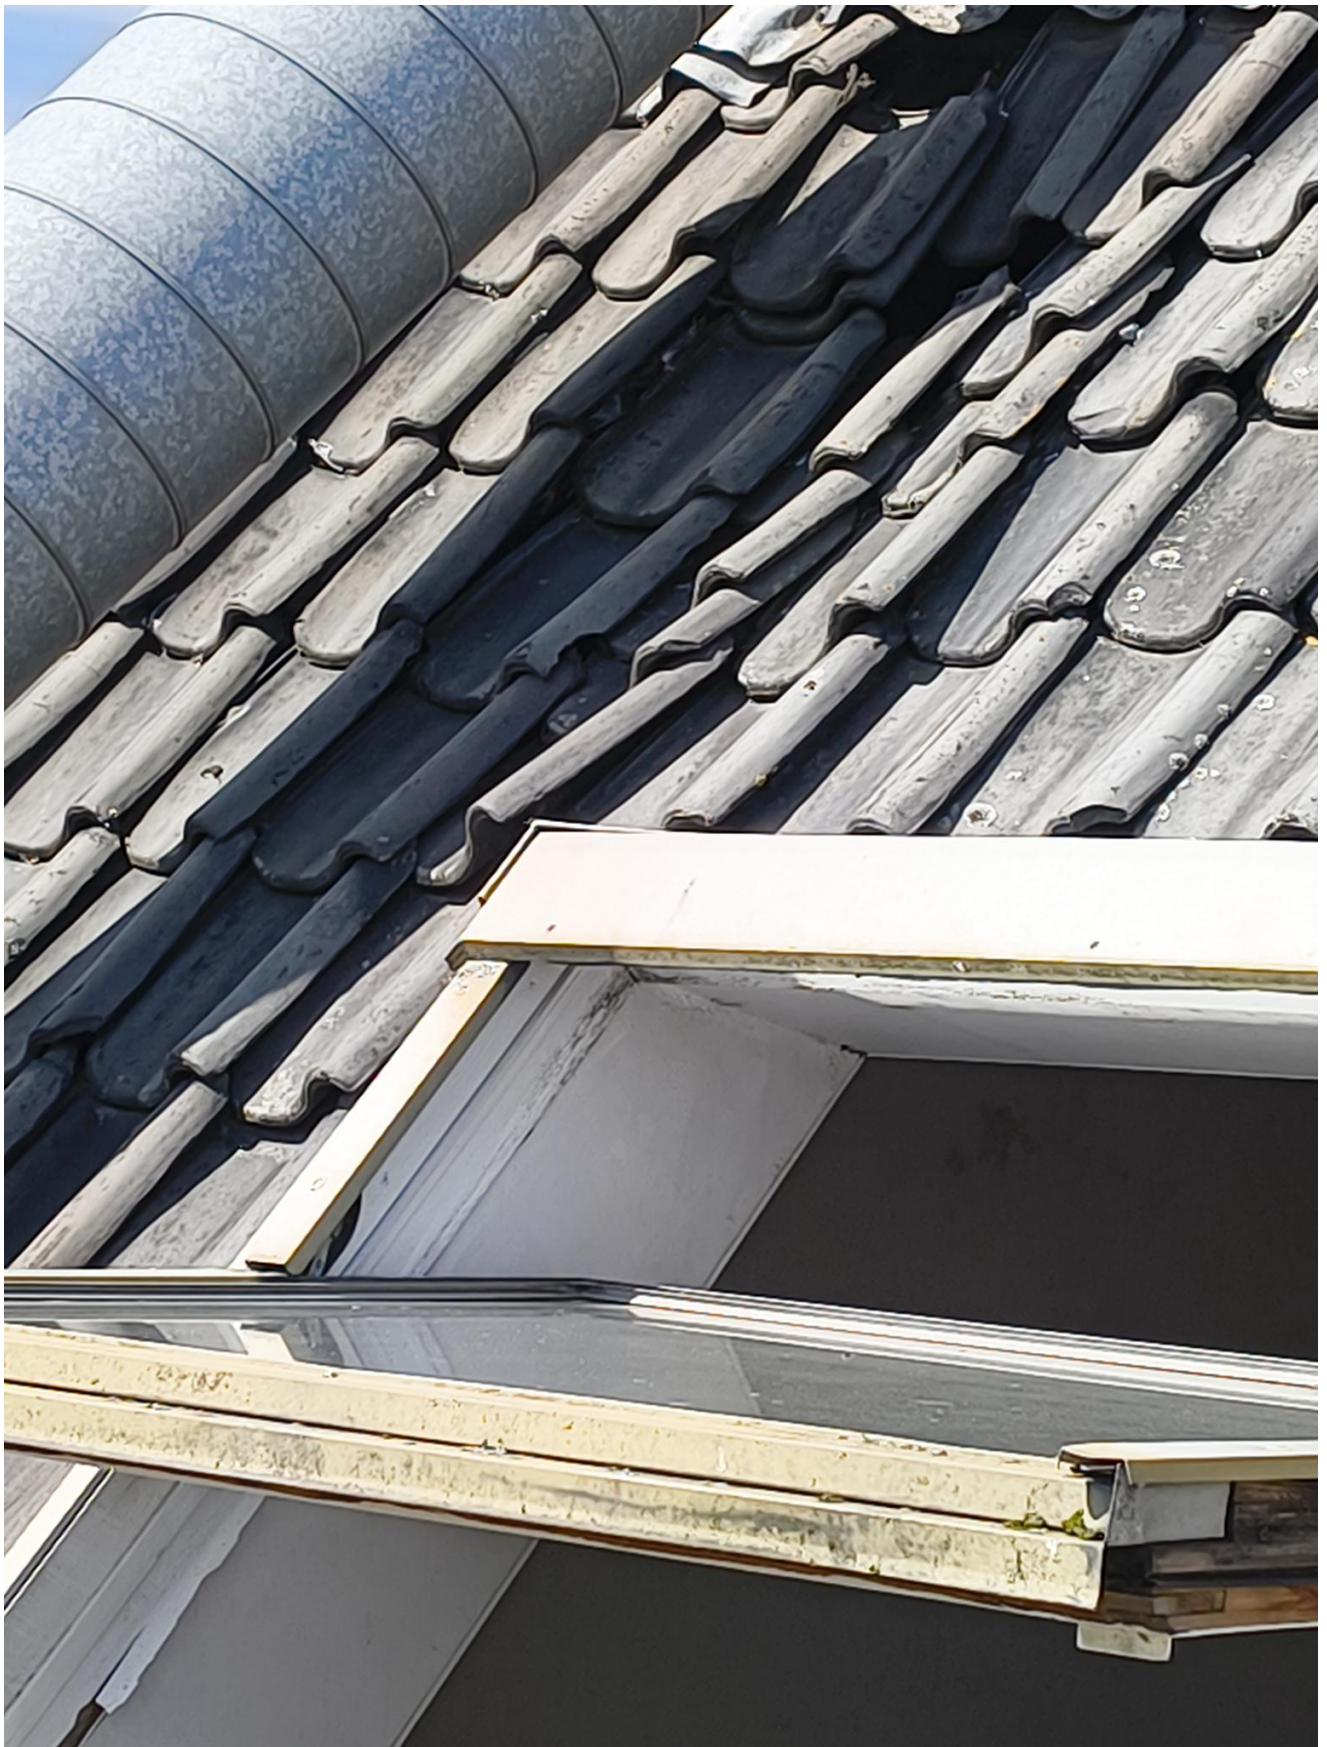
Tile slumping upper part
