The [REDACTED] has roof damage on multiple points. The following document will describe and visualize the damage.

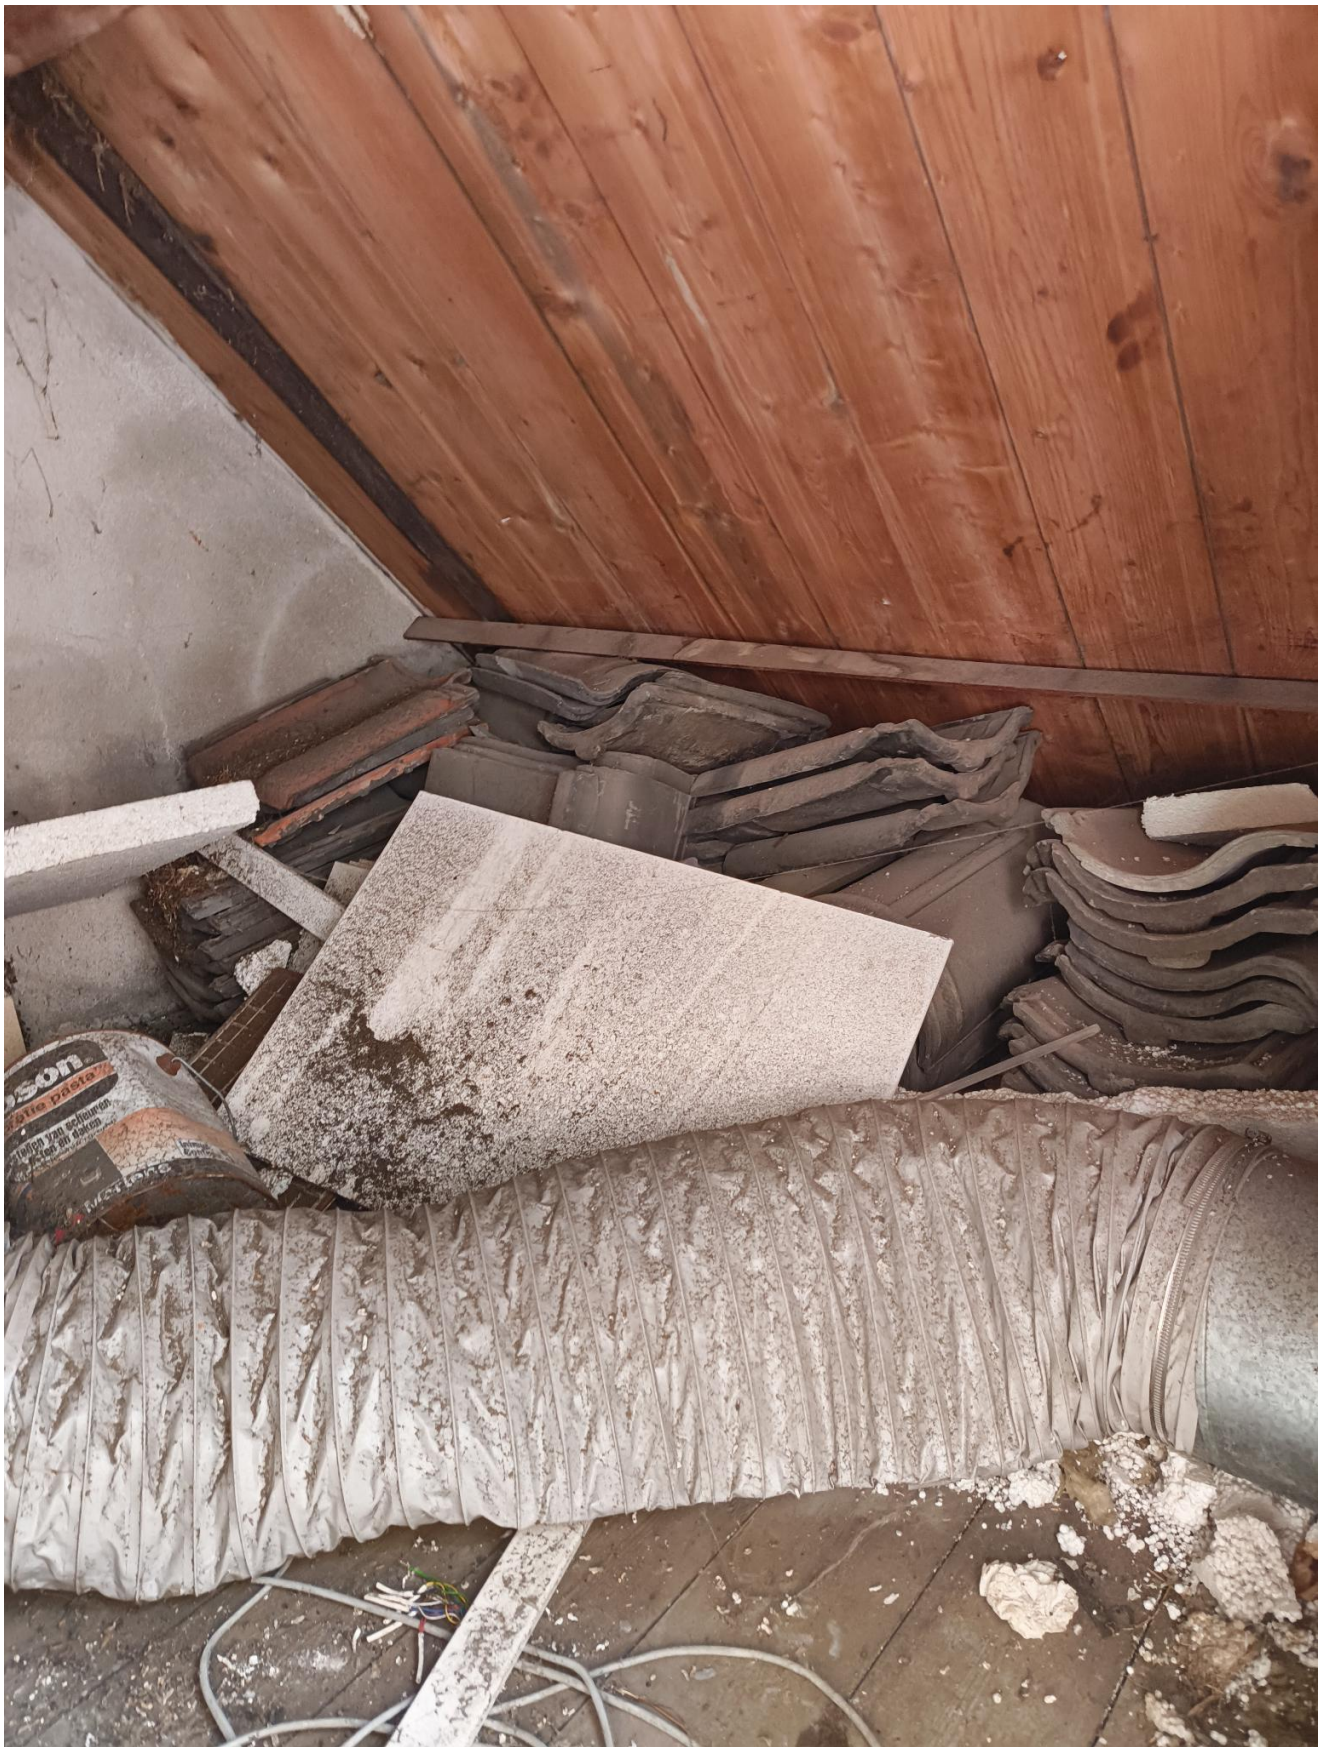
Now finally for some good news. There seems to be a stash of roof tiles in the cubby whole in the shower. This means that we potentially don't need to buy or acquire any extra tiles.
