The [REDACTED] has roof damage on multiple points. The following document will describe and visualize the damage.

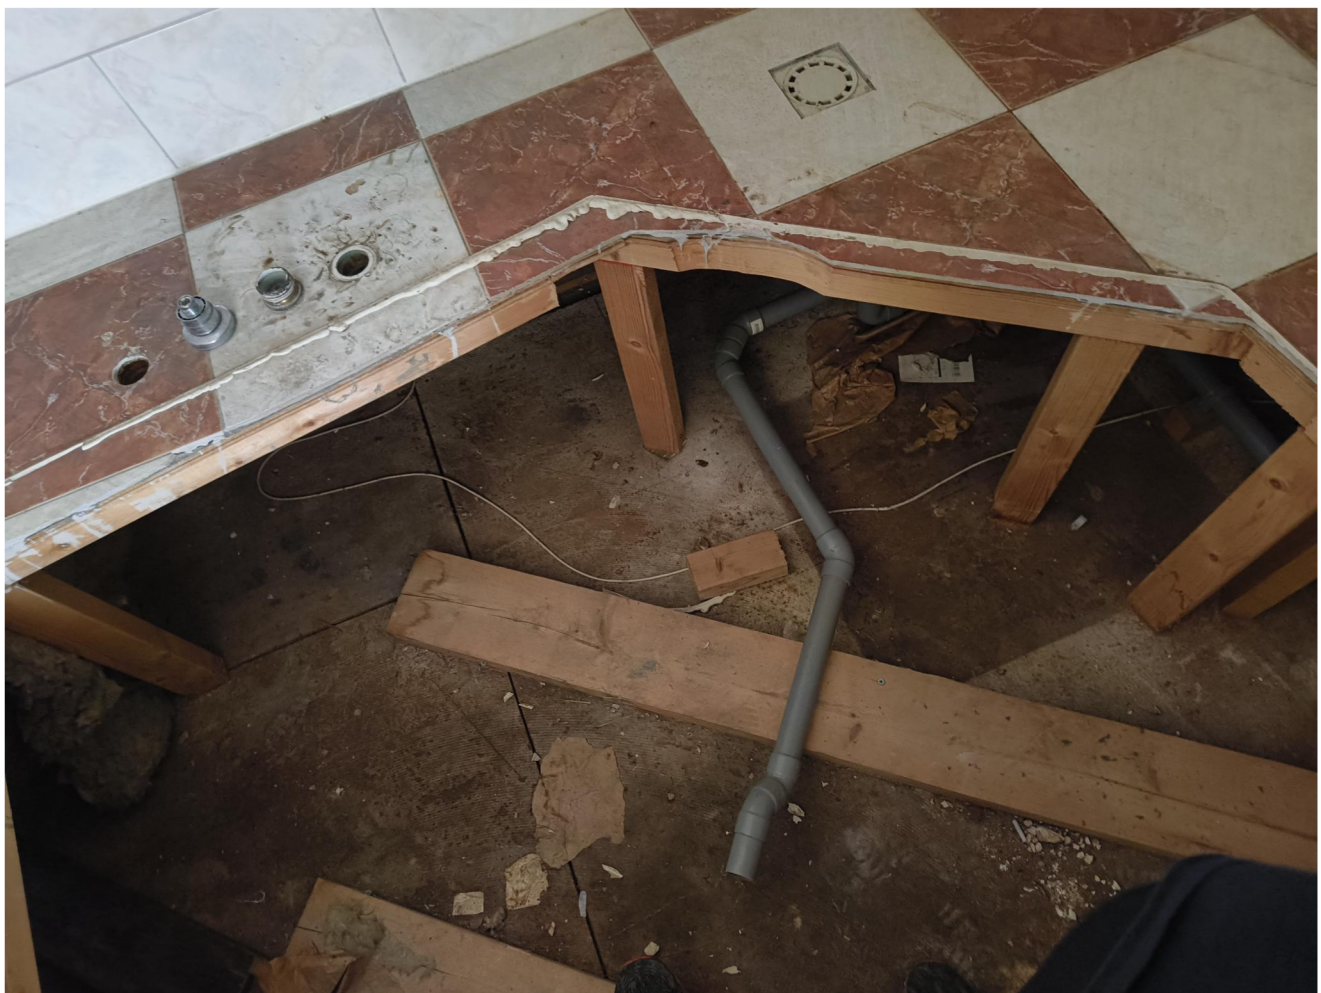
We will start from the 3rd floor. When entering the floor and you look on the right there is a place where there was a bath tub once. Underneath there seems to be light coming from the far corner of the roof. When standing in front of the building it seems like the corner of the roof tiles is gone. This seems to be an easy enough fix.

On the floor beneath this spot there is the old kitchen. There seems to be no serious water damage there so my assessment is that this missing tile is not causing major damage but would be good to fix either way.

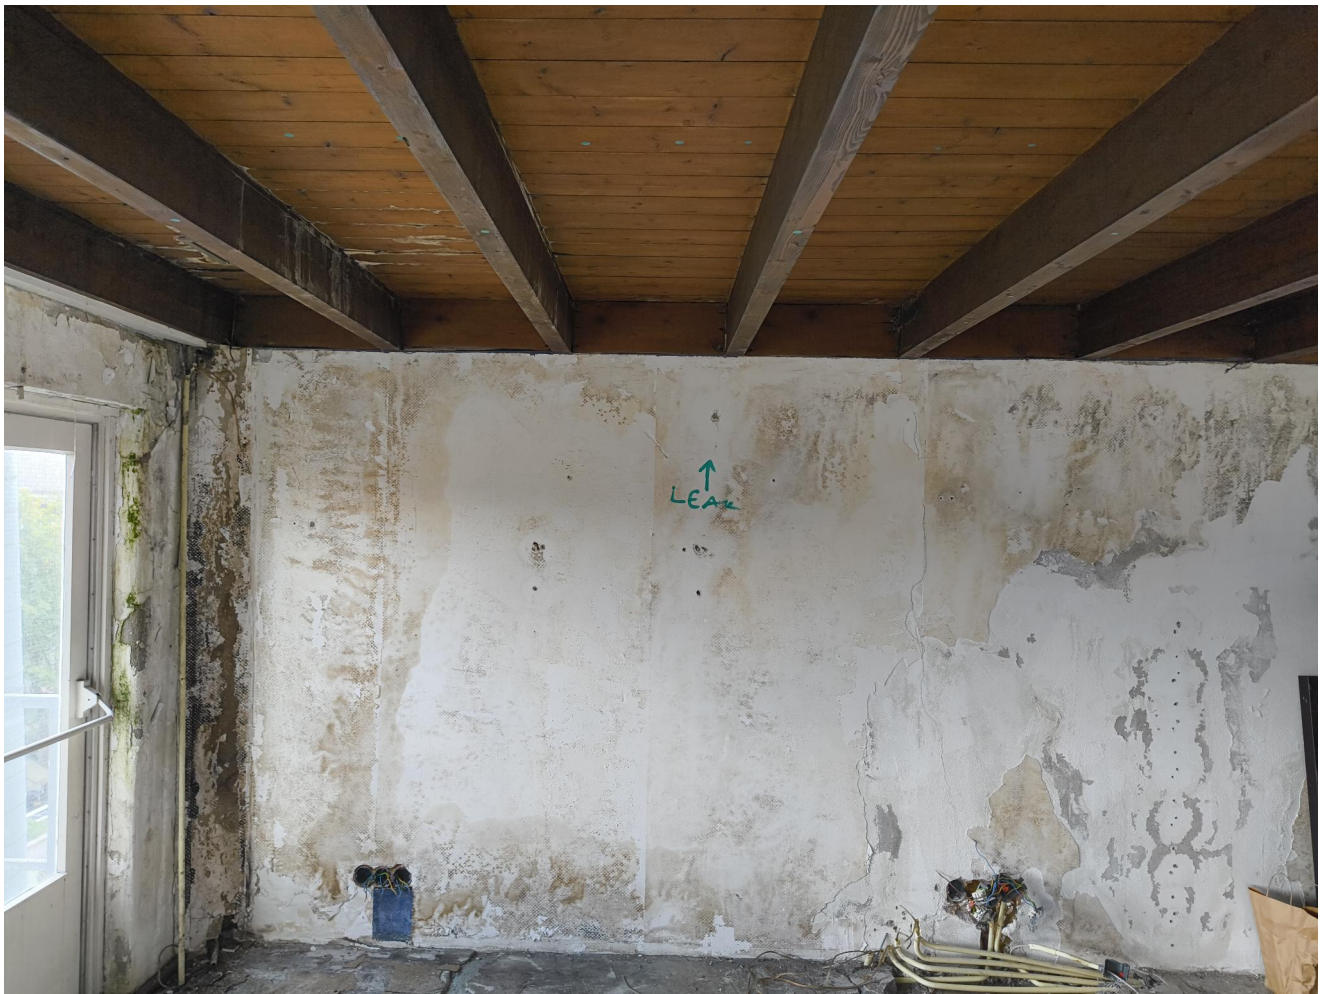
When moving across to the far end of the 3rd floor there is a room where the water damage is serious. The floor is seriously damaged and the damage has progressed to the floor below where there is clear signs of water damage on the walls. The hole in the roof seems to mostly due to 2 things.

- the ventilation that was installed here but is not functional anymore both on this floor and has connections on the attic
- The damage that followed from this ventilation on the structure and the collapsed tiles that can be seen from the outside.

water damage floor 2

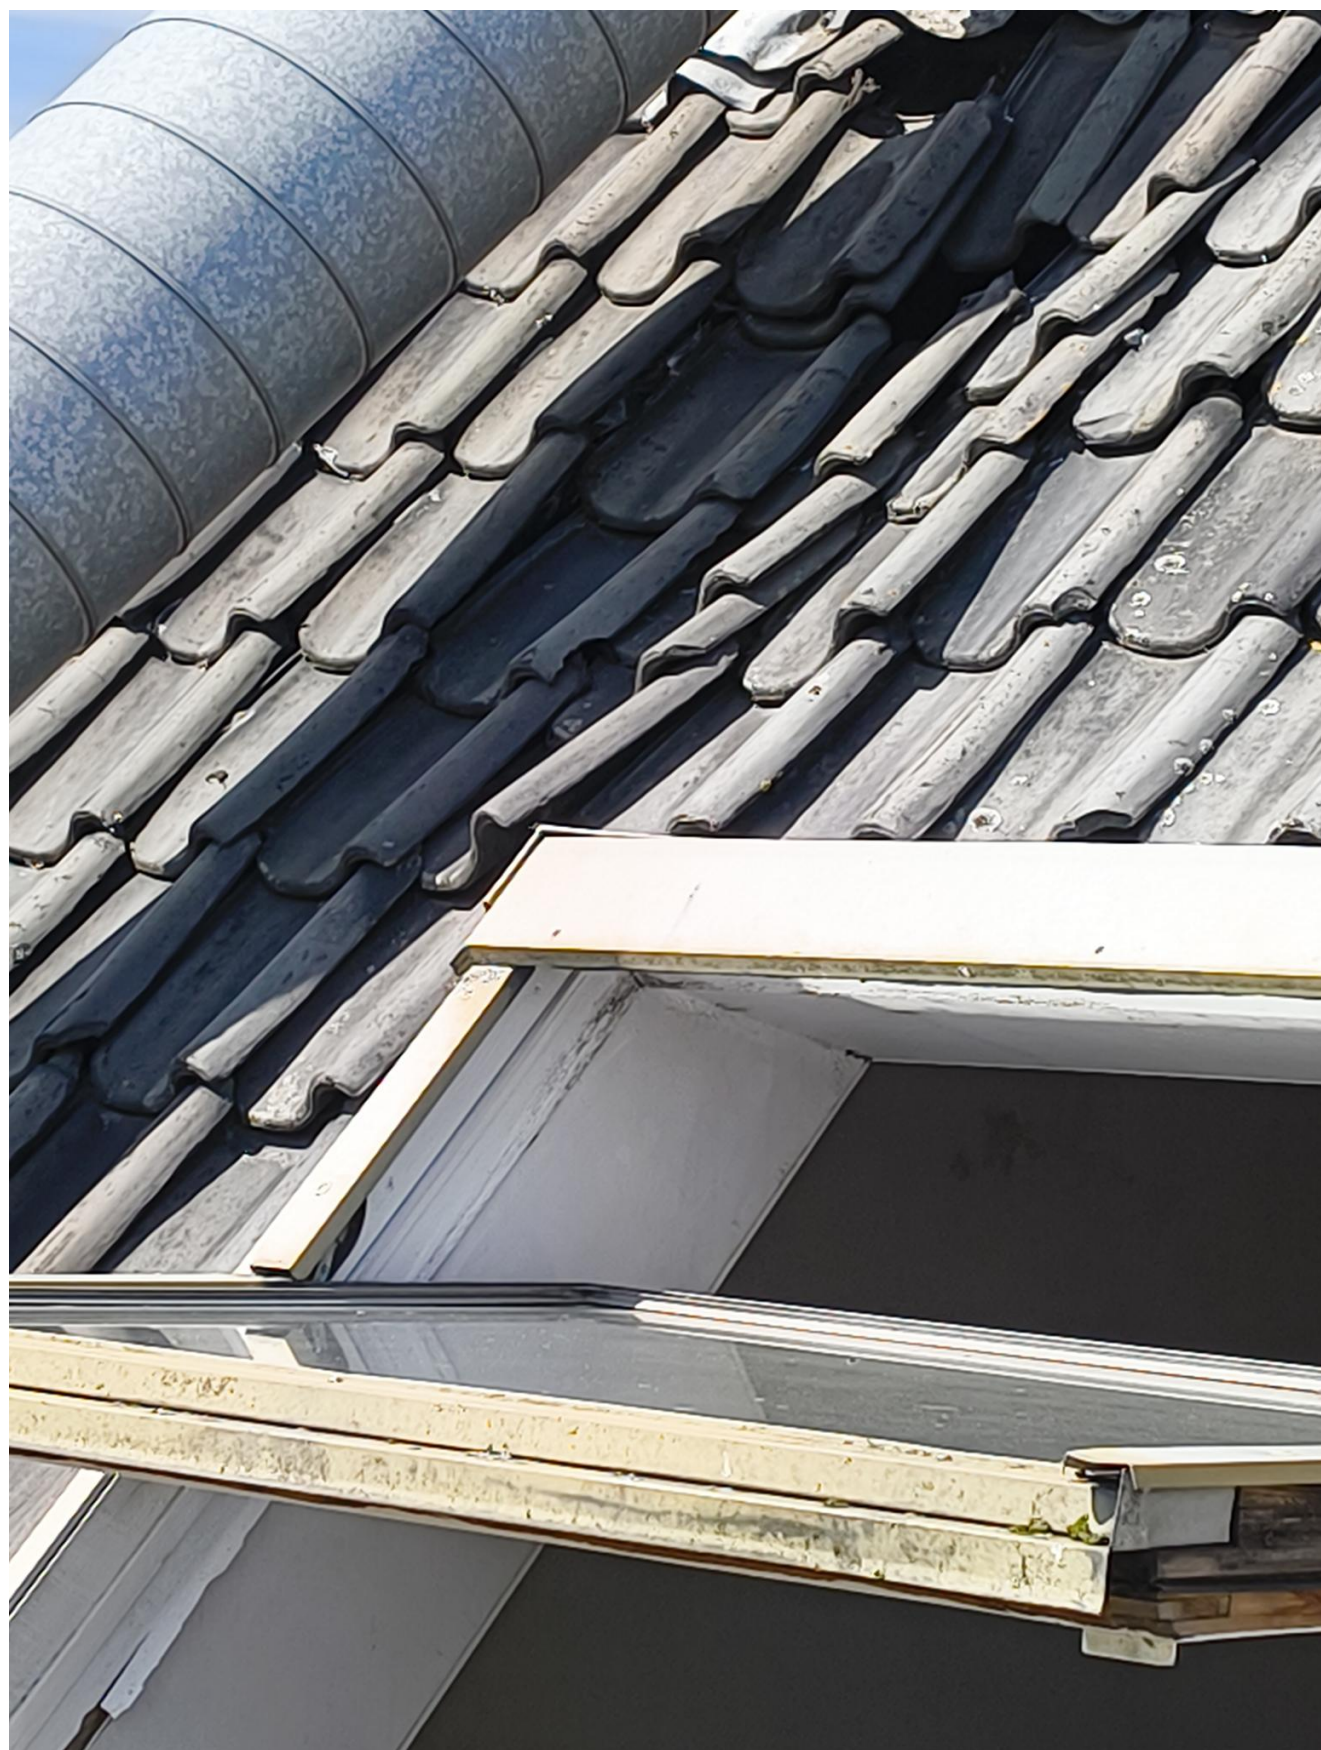
This is the last hole at the far end of the attic. This is a ventilation pipe that is right above the Floor 3, hole 2 at the far end of the 3rd floor. This is part of the same problem. From the outside there is clear damage of slumping tiles that causes this to be one continuous problem causing the third floor and second floor to be damaged.

Tile slumping upper part
